A REPORT ON THE BEHAVIOUR OF STRUCTURES EMPLOYING PRESTRESSED CONCRETE DURING NIIGATA EARTHQUAKE

Dr. Shunji Inomata*

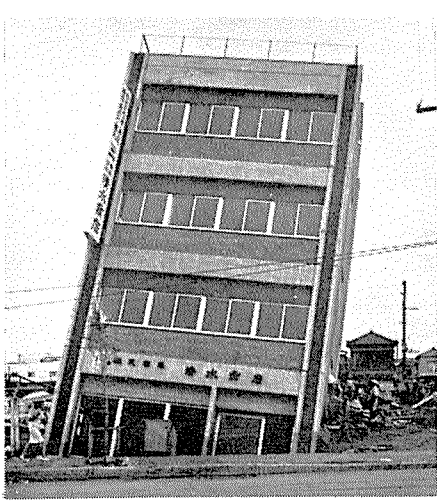
Fig. 2 Reinforced concrete building tilted over and subsided

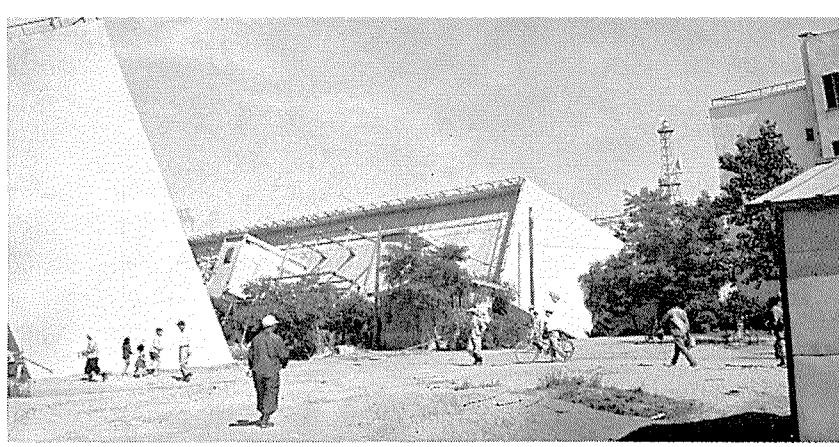
Fig. 3 4 story reinforced concrete building tipped down

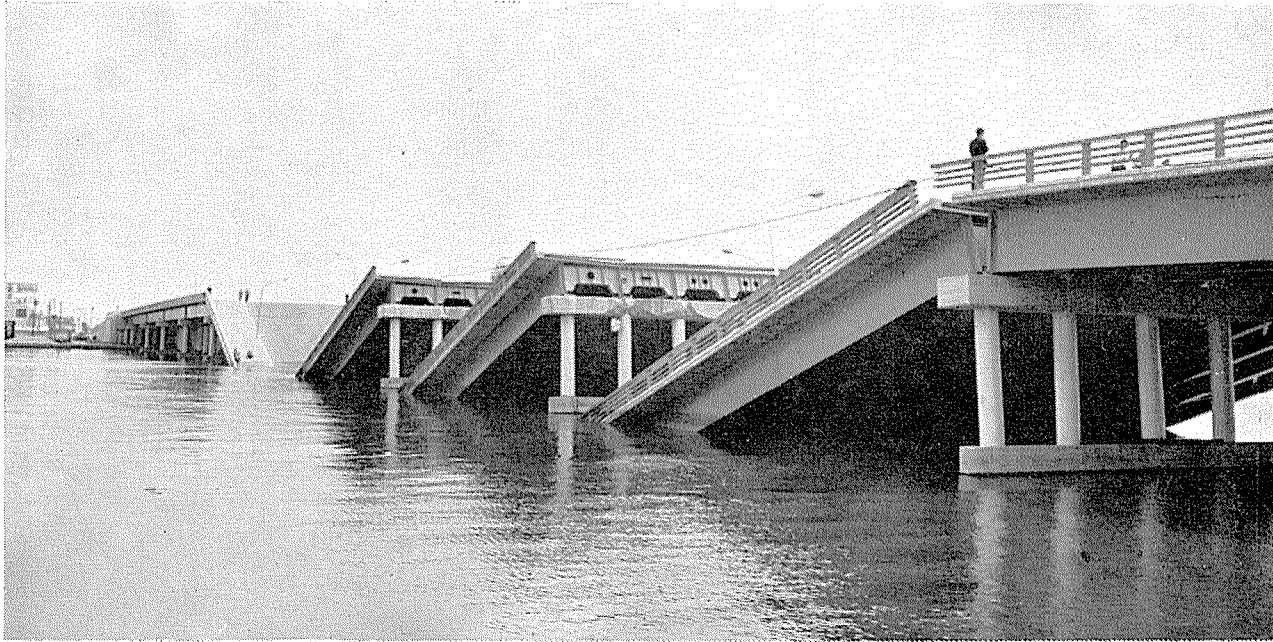
One large steel bridge girders fell into the Shinano River due to the extensive subsidence of steel bent founded on steel piles and the girder of adjacent four span pulled off the steel bents and collapsed over the river (Fig. 4).

Fig. 4 Steel bridge fell into the Shinano River (Shin-Showa Bridge)

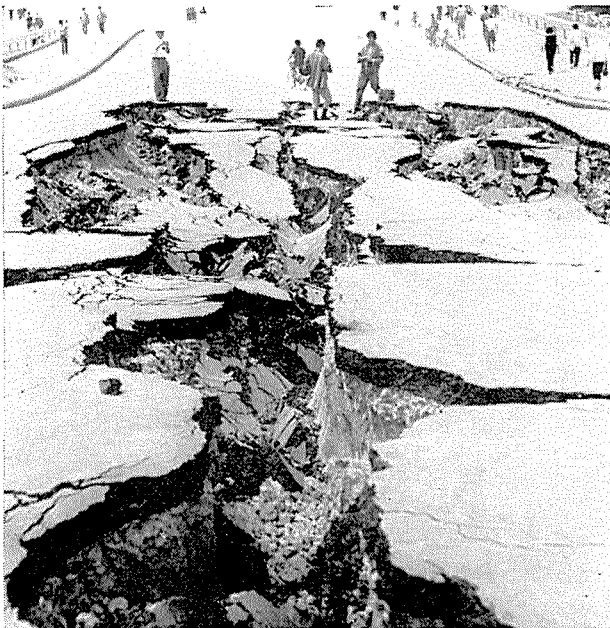
Unfortunately the main fault or subsidence area occurred through the centre of Niigata City, as would be expected no structures could withstand this type of displacement (Fig. 5).

Fig. 5 Extensive subsidence of embankment of Shin-Showa Bridge

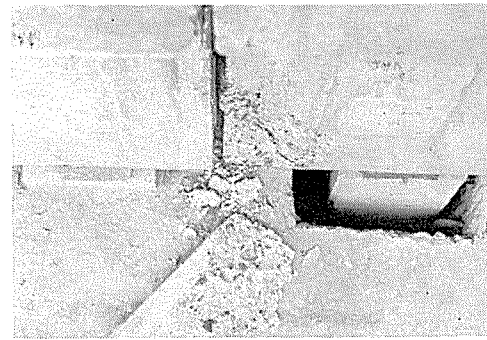
- 1) Instances of hammering of the end of girder against each other were observed and spalling of concrete at the end of girder was observed (Fig. 6, 7, 8).
- 2) Vertical and horizontal cracking was frequently visible on the top face concrete of abutment or pier where bearing of prestressed concrete girder was connected to it by shear dowels (Fig. 9, 10, 11).
- 3) Hammering of concrete movable rocker bearing against the wall of the hole where the rocker bearing was placed. Cracking of concrete of abutment or pier was frequently visible. The earthquake emphasized again that the structures should be properly spaced or jointed to prevent

Fig. 6 Hammering of the end of beam against each other. Spalling of concrete at bottom of beam.
(Shiroyama Bridge)
Overall length..... 120 m (4×30 m)
(Pcst-tensioned)
Width of carriage-way.....5.5 m

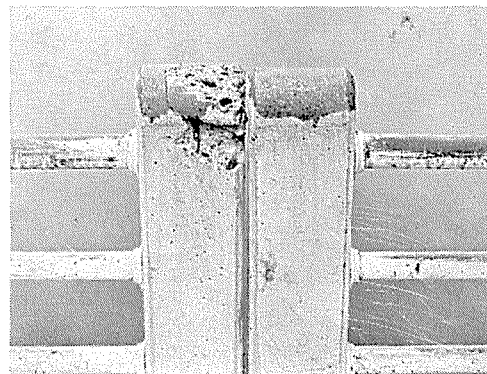
Fig. 7 Spalling of concrete at top of hand-railpost (Shiroyama Bridge)

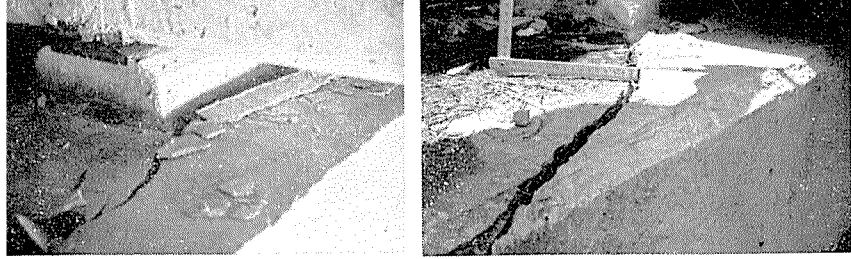
Fig. 10 Cracking of abutment (Komatagawa Bridge) (Post-tensioned)
 All-Over length.....50.0 m (2×24.96 m)
 Width of Carriageway.....5.5 m

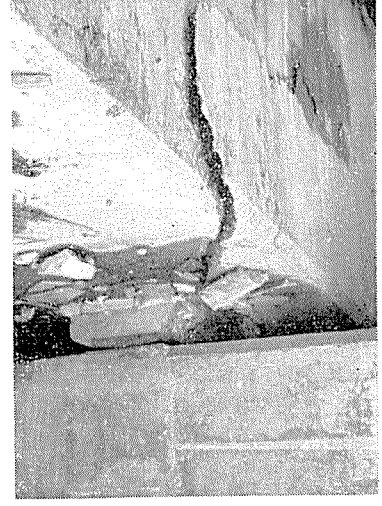
Fig. 11 Cracking of abutment (Komatagawa Bridge)

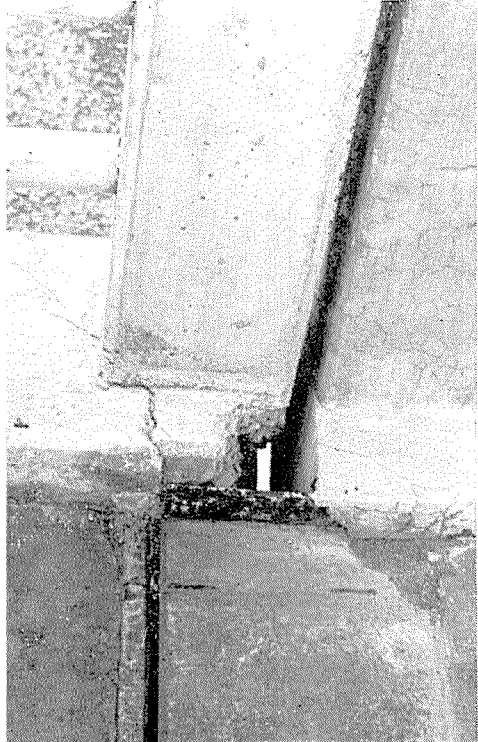
← **Fig. 8** Cracking of Concrete at deck level (Yasuda Bridge) (Post-tensioned)
 Over-all length.....825 m (23×25.80 m)
 Width of carriageway.....6.00 m

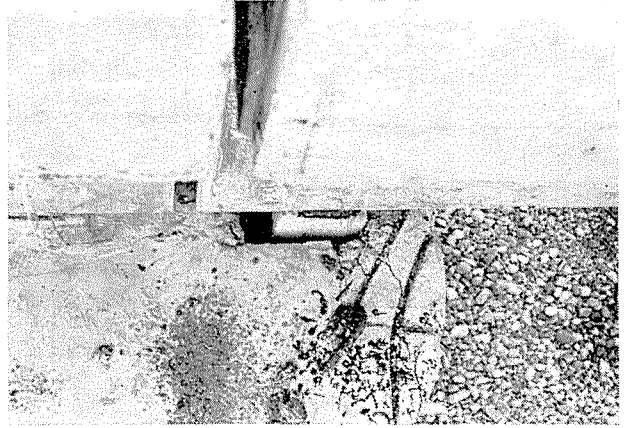
hammering of adjacent parts (Fig. 12).

Fig. 12 Hammering of concrete movable rocker bearing against wall of hole caused cracking of concrete pier (Yasuda Bridge)

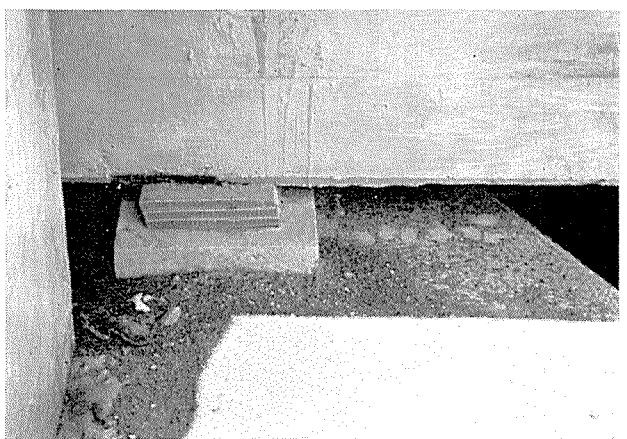
- 4) Rubberpad bearing deformed extensively during the earthquake and did not recover the original position (Fig. 13).
- 5) Abutment and pier shifted or tilted, apparently due to liquidaion of weak sandy and silty foundation materials.
- 6) Cracking and sometimes crushing of concrete was observed on the wingwall of abutment.

Fig. 13 Rubber pad bearing tilted over (Kosaka Bridge) (post-tensioned) Over-all length.....60.50 m (2×30.20 m) Width of carriageway.....6.0 m

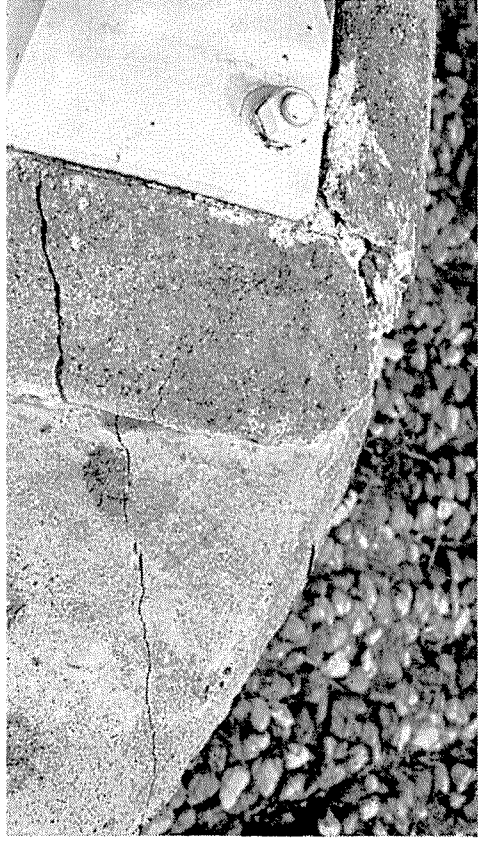
← **Fig. 9** Cracking is visible on the top face concrete of pier (Yasuda Bridge)

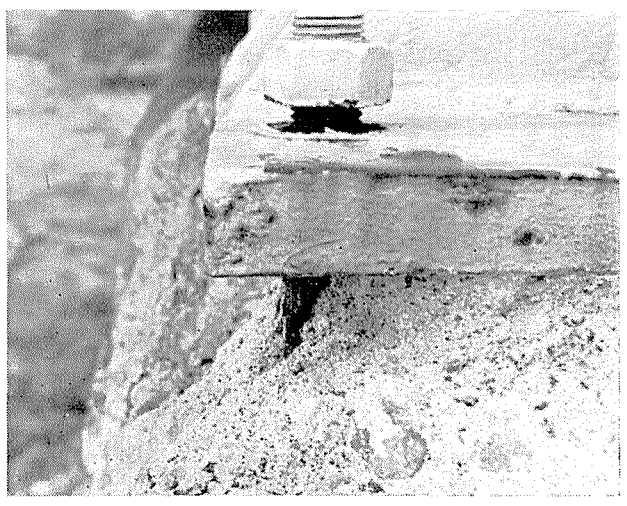
No damages, for example shearing off the bolts, have been observed on all the prestressed concrete bridges and also no falling down of girders has been observed. But in the absence of any suitable cover of concrete to the embedded bolts or appropriate arrangement of mild-steel bars around the pier cap and bolts, the concrete cover has been destroyed due to the horizontal movement of bolt. Sometimes the pull-out of the bolt has been observed in the absence of insufficient length of embedded bolt (Fig. 14).

The anchor bolts holding the bearing plates into the piers or abutments tended to pull out of the thin covered concrete and cracked the concrete. In many cases the anchor bolts pushed the concrete cover and made it cracked. It would appear that this failure of the concrete could have been overcome if adequate mild steel had been provided around the anchor bolts. Furthermore it was evident that the thickness of concrete covering was not sufficient to resist to the horizontal pulling force of the anchor bolts. It is not able to discover the exact design method to which the anchor bolt should be designed but it would appear that the existing shear dowels would not have sufficient strength as a whole.

Fig. 14 Pull-out of anchor bolt (Yasuda Bridge)

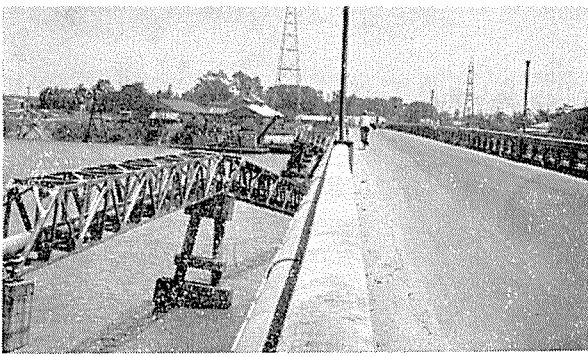
Fig. 15 Teiseki Bridge

This bridge is 272 m long with 6 m carriageway with 13 spans over the Shinano River. The piers were cast in situ on precast concrete piles. The deck is consisted of pre-cast beams post-tensioned longitudinally and transversely through the deck and the diaphragms. All tendons are fully grouted and bonded. All beams are adequately connected to the piers against horizontal forces with shear dowels. Despite considerable displacement of the foundations and possibly of the river bed, the bridge has suffered no visible damage at all. It is interesting to see that several of the central spans of an adjacent steel pipe bridge have collapsed and are leaning against the undamaged prestressed bridge (Fig. 15).

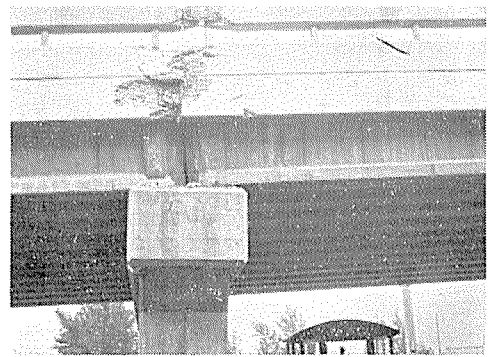
is 203 m long with 8.00 m carriageway, with 15 spans. Beams were supported on reinforced concrete portal frames. There was considerable movement of the piers, some of which moved from 1 cm to 30 cm vertically relative to one another, and horizontally by as much as 40 cm at the top. Because the center steel span was not properly secured, it pulled off the supports and collapsed over the national railway line (Fig. 16). Apart from minor spalling over the piers at deck level, the prestressed portion of the structure was undamaged (Fig. 17, 18, 19)

Fig. 17 Spalling of concrete at deck level

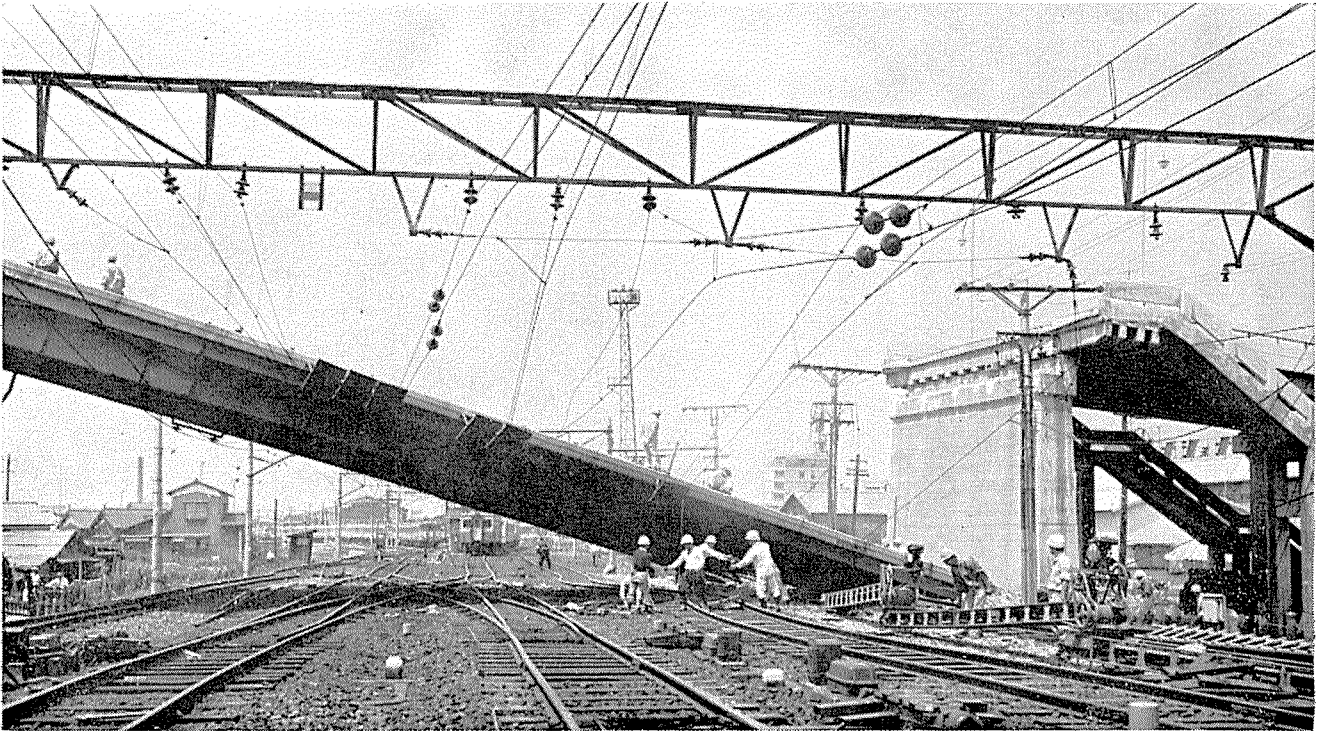
Fig. 16 Center steel span pulled off the support and collapsed over National Railway Line

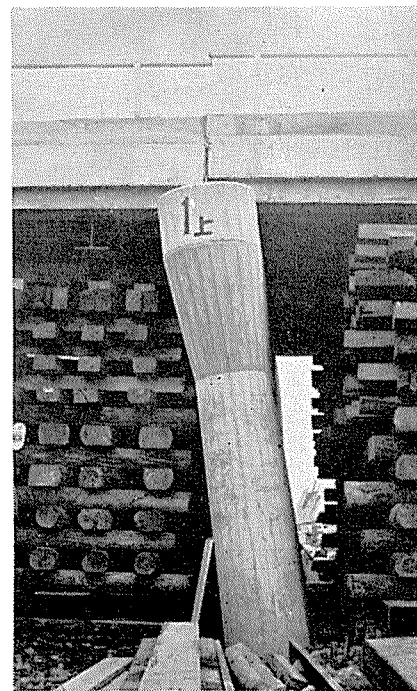
This bridge has structural steel main spans over the Shinano River with approach two spans consisting of pre-tensioned standard beams with cast-in-situ concrete prestressed by transverse tendons. This approach bridge has two span of 7.5 m long each with 8.5 m carriageway. There was considerable movement of the piers, some of which moved by 30 cm vertically and also extensive subsidence of the approach embankment was observed (Fig. 20). Due to this extensive subsidence and the vibration during the quake, piers simply tilted over as shown in Fig. 21 and Fig. 22 and spalling of concrete at the end of beams was observed.

Fig. 21 Pier tilted over

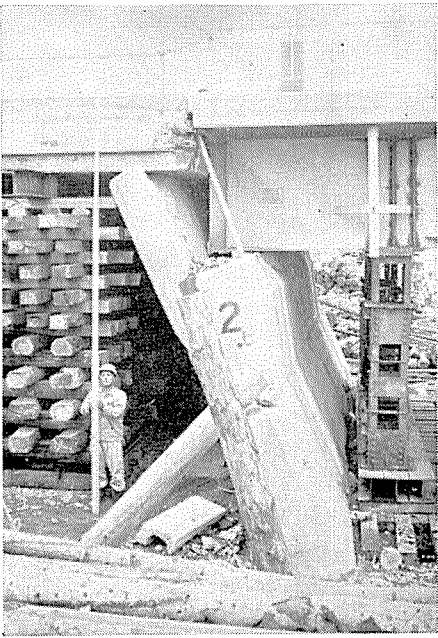
Fig. 22 Pier tilted over and spalling of concrete is visible

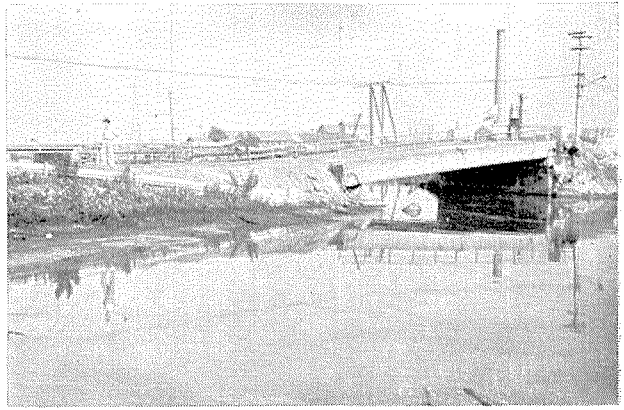
This bridge is 15.0 m long with 7.70 m carriageway and the deck is consisted of cast-in-situ concrete slab post-tensioned longitudinally. One abutment slid forward and tipped over backward during earthquake (Fig. 25), but the prestressed concrete slab was undamaged.

Fig. 25 One abutment tipped over

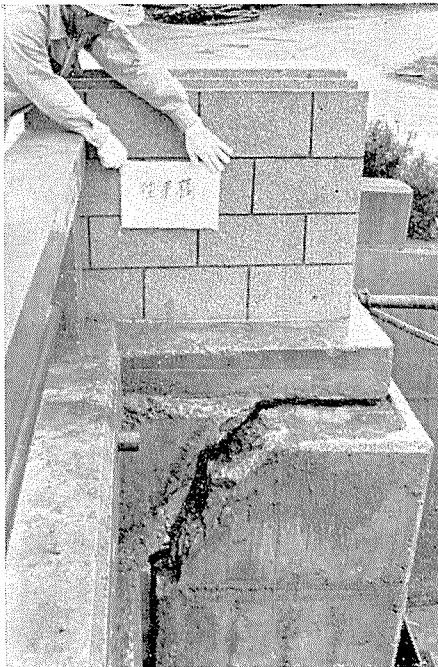
The bridge has an overall length of 63.0 m with five equal spans. The bridge provides 5.5 m wide carriageway and is consisted of pre-tensioned standard beams with cast-in-situ concrete prestressed by transverse tendons. Second pier subsided by about 4 cm but no damage was observed in the prestressed portion of the structure. But horizontal and vertical cracking of wing wall of abutment was visible (Fig. 23).

Fig. 23 Cracking of wing-wall

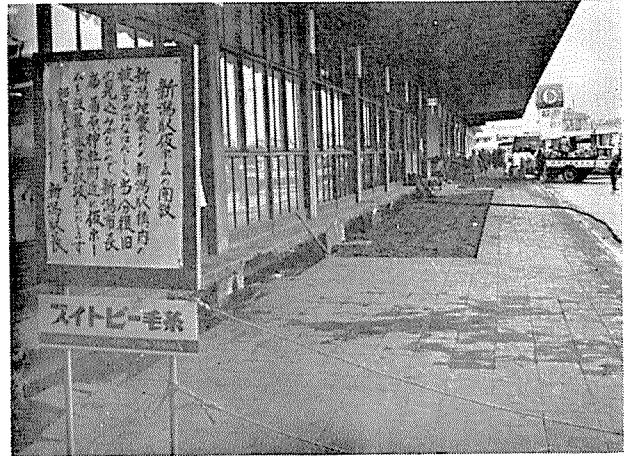
The main part of this structure (18 spans of 5 m length each) is founded on precast concrete piles but the annex (3 spans of 6 m length each) is founded on soil-cement foundation. The foundation material (very fine sand) is apparently appears to have subsided by about 50 cm during earthquake (**Fig. 27**). The structure founded on concrete piles has withstood the movement extremely well and no damage could be observed in the prestressed members. But the structure which was not founded on concrete piles has subsided by about 35 cm relative to the main part of the structure.

Fig. 27 Subsidence of foundation material

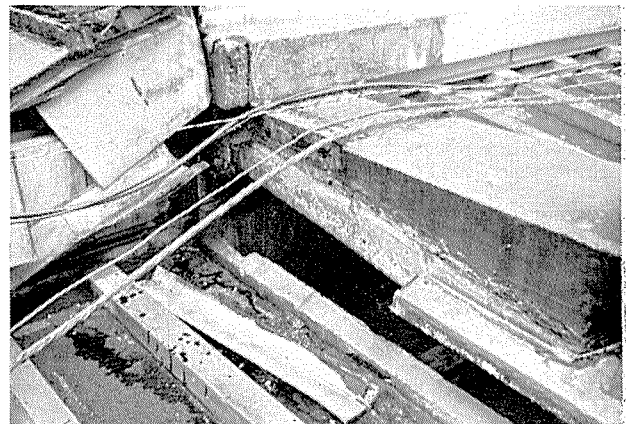
Because of this difference of subsidence between two parts, the frame of first one span in the annex was subjected to unequal settlement of column and the ends of beam and the cantilever beam were partially cracked and also crushed (**Fig. 28, 29**). The prestressed concrete roof member was also damaged on the cracked column. But no damage could be observed on the end two spans of the annex.

This damage is apparently caused by difference of extensive and irregular subsidence of the foundations between two parts.

Fig. 28 Top view of failed members

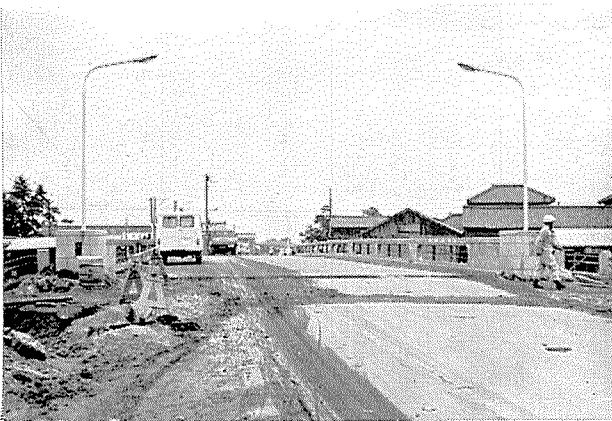
The bridge has an overall length of 56.0 m with five equal spans, providing 9.5 m wide carriageway. The deck is consisted of pre-tensioned standard beams with cast-in-situ concrete prestressed by transverse tendons. Extensive subsidence of approach road surface was observed but the structure was undamaged at all (Fig. 24).

Fig. 24 Extensive subsidence of approach road is observed

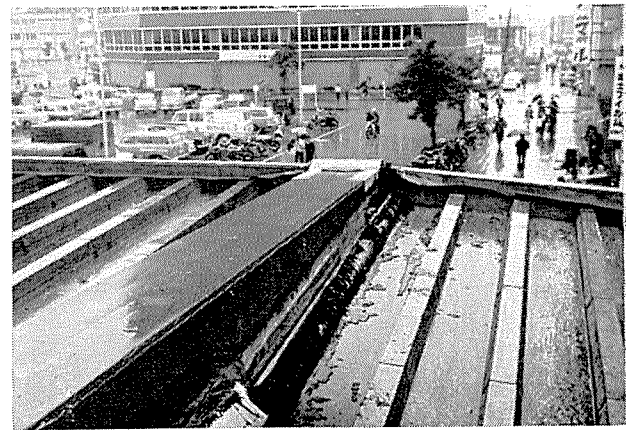
Fig. 29 Top view of difference of subsidence between main part and annex part
