Damage Inflicted on Concrete Structures during Tokachioki Earthquake and Concept on Aseismic Design

By **Tatsuo Nishiki***
Yoshio Ozaka**

1. Preface

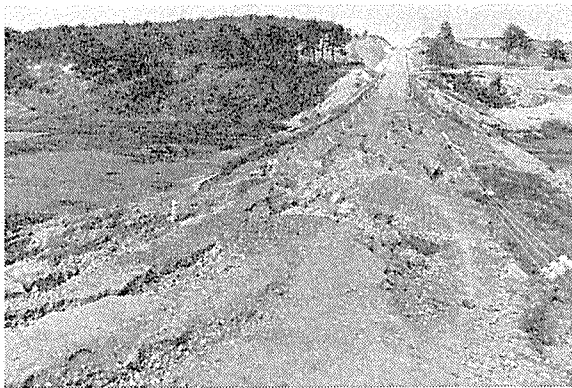
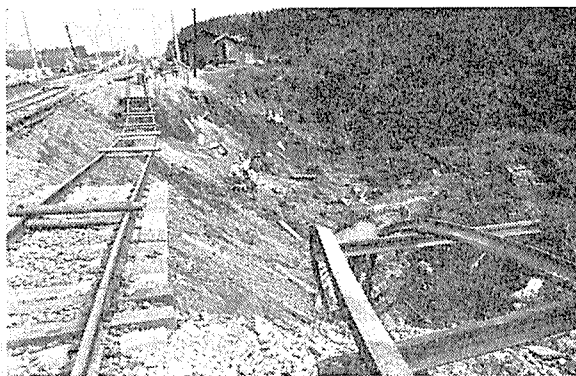
A considerable damage was seen done to the railway and highway sections set up by banking. As shown in Fig. 4 (a), (b), there were many places where the banking foundation collapsed and sank. Many banking slopes saturated with the

rain water were completed of destruction by the Earthquake. Some cases of banking flowage were found, too.

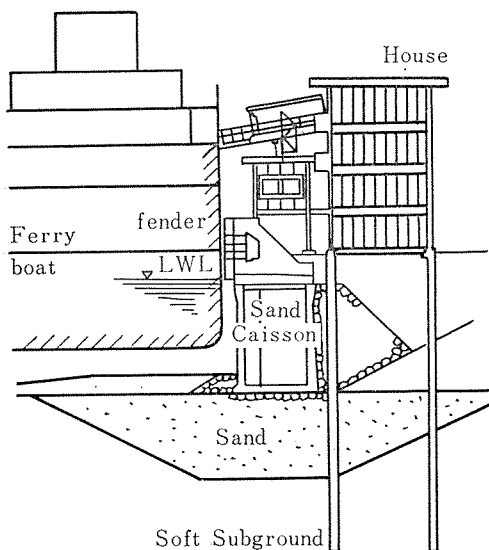
Fig. 5

Aomori harbor and various equipments near by the wharf. The cross section of the wharf is shown in Fig. 5. There is a soft clay layer of about 40 m under the sea bottom near the wharf, and the shipping facilities are set up floating over this soft clay layer. Built in 1924, the foundation of these facilities had been sinking down, reaching about 2.7 m down the original level before the Earthquake hit. The damage to the facilities,

generally speaking, were heavier where the sinking were greater. Near the No. 2 Wharf, the Earthquake caused the sinking to reach about 60 cm, and at the same time it seems to have caused the quay walls to incline toward the seaside to some extent.

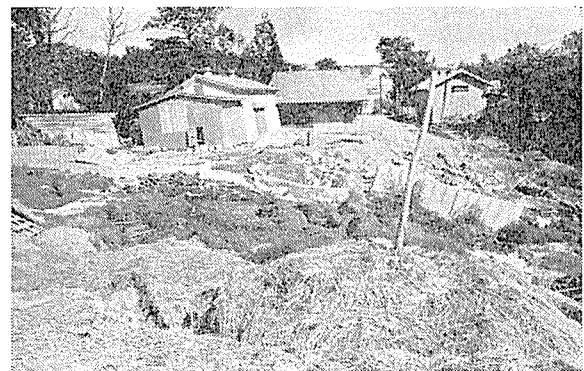
Buildings were found damaged in places in the afflicted areas. Wooden buildings were seen collapsed or broken down due to landslide, irregular foundation sinking, etc. Generally speaking, most of the wooden structures were seen to

Fig. 6 Wooden houses

have simple foundation, being small in scale and light in weight, and it seems natural that many had sustained damage due to irregular foundation displacement. **Fig. 7, 8 and 9** show some examples of reinforced concrete buildings that sustained serious damage during the Earthquake. Notable of the damage done are : large diagonal cracks in the columns, crumbling of concrete of column, buckling of longitudinal bars, breaking up of bar anchorage, tie disabling, tie bar breaking, diagonal cracks on the walls and the beams, and collapsing of columns and entire walls. In the case of some reinforced concrete buildings, considerable damage was found done even when there was no notable irregular foundation sinking or landslide.

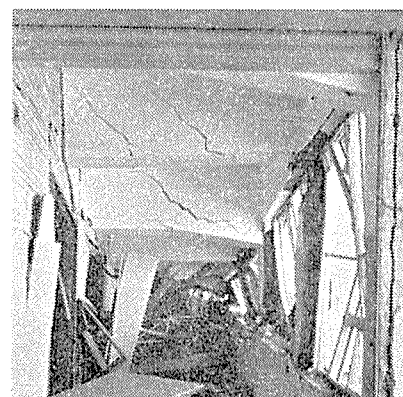
Fig. 7 Diagonal cracks of reinforced concrete beams

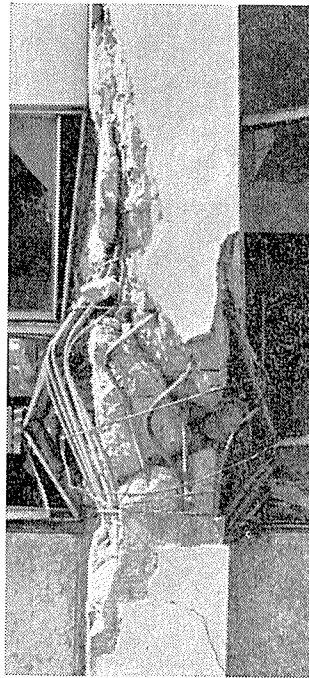
Fig. 8 Breaking up of tie bars and buckling of longitudinal bars, Concrete crumbled.

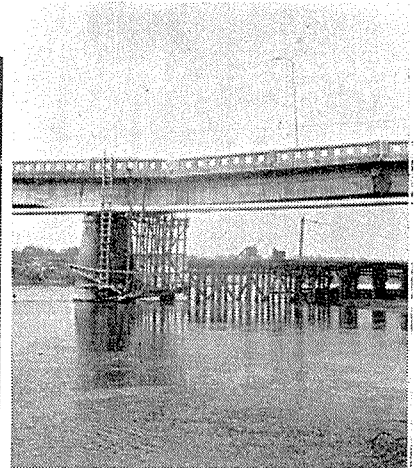
Examples of damage done to reinforced concrete bridges are shown in **Fig. 10**. The Shiriuchi Bridge is a 22.5 m span reinforced concrete bridge of cantilever type. Its pier foundation near the central part which had been noted sunken to some extent sank further during the Earthquake, causing the bridge pier at the same time to dip and break the cantilever part of the girder. In the case of the reinforced concrete aqueducts in **Fig. 11**, displacement was noted near the abutment, and some shear crack occurred in the shear key on the upper end of the pier, though no water was found leaking.

Fig. 10 Shiriuchi Bridge (Reinforced Concrete)

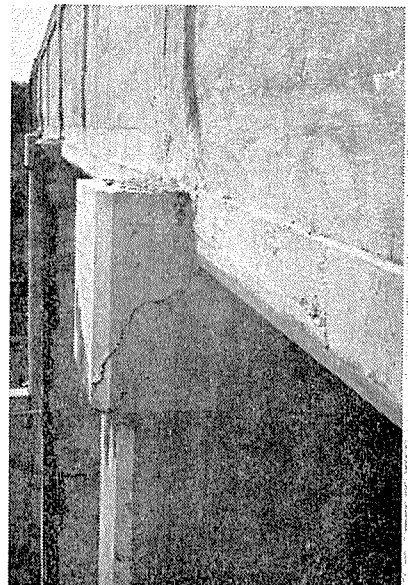
Fig. 11 Reinforced Concrete aqueducts

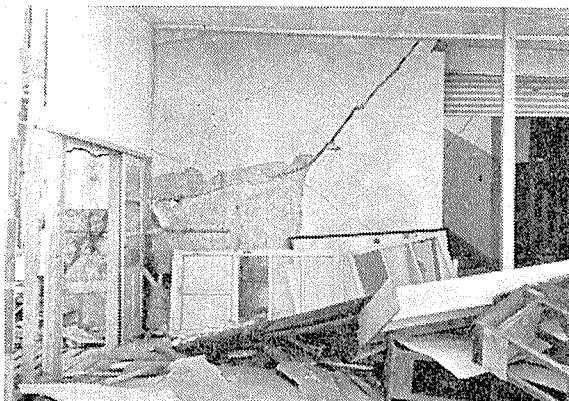
Fig. 9 Diagonal cracks of wall

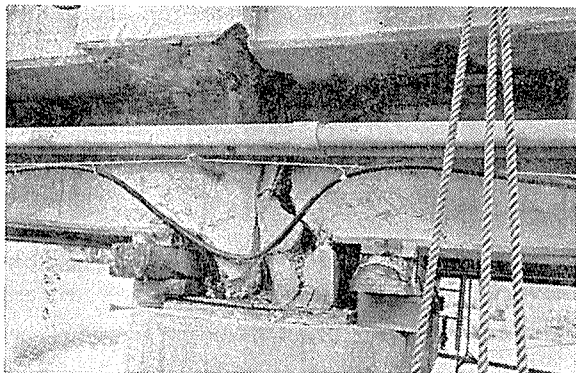
The Komoto Bridge has a 40 cm high cross beam at its supporting part, and on this cross beam some large diagonal crack

was seen (**Fig. 12**).

Fig. 12 Komoto bridge (Reinforced Concrete)

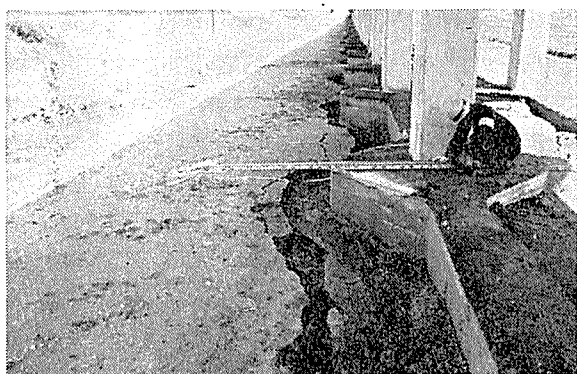
The Anenuma Elevated Bridge is of ordinary type of structure seen commonly among elevated railway bridges in this country. The columns are rigidly connected by horizontal beams near the ground surface, and four precast reinforced concrete piles are driven in as foundation piles under each column. A 20 m deep layer of extremely soft soil lies near by over the supporting layer, with several meters high banking running parallel to the bridge some 20 to 30 m apart. With the underground water level coming so close to the grand surface, it had been thought that execution

Fig. 13 Anenuma railway viaducts (Reinforced concrete 3-span continuous rigid frame)

of work would not be easy if the beam to be connected to the columns were to be located below the ground surface, as the underground water would then spout out. So, the beam was set up above the ground surface, and fine sand was used for the banking to bury the beam. At the time of the Earthquake, a dynamic displacement of about 70 cm in the direction right angle to the track is presumed to have taken place, judging from some ground surface cracks near the elevated bridge and to the disturbance in the track alignment. A dynamic displacement of about 10 cm at least is also presumed to have occurred in the direction of track, judging from some deformation of the joints between the bridge blocks and to that of construction joints of the railing. After the Earthquake, the position of the elevated bridge is seen partially moved about 10 to 30 cm away from the original position. The surface of the rice paddy near the elevated bridge in opposite side of the banking is seen to have partly risen about 5 to 10 cm.

No special rehabilitation work was needed to be done about the damaged spots for both the Anenuma and Ogawara Elevated Bridges before letting the repairing train pass through on to other afflicted areas.

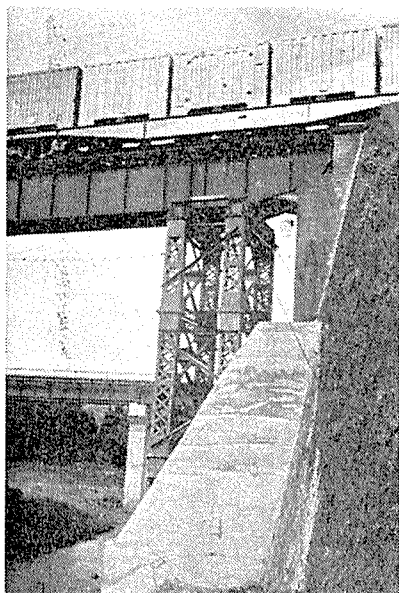
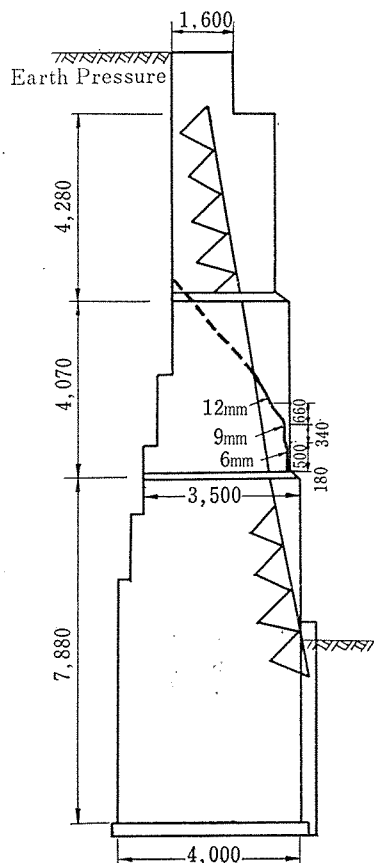
Fig. 14 shows a brick abutment, about 16 m high, with some bending shear crack on. In the cracks bricks and joints are seen broken.

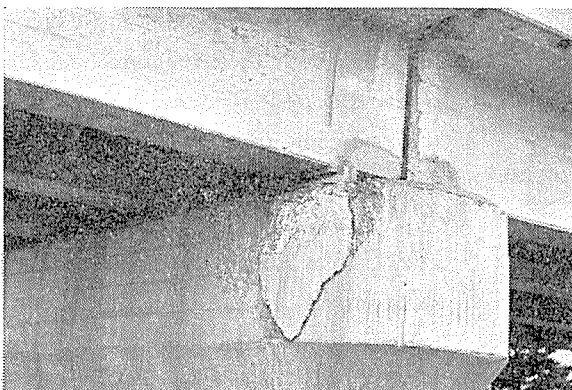
Fig. 16 Cracks on the bearing surface and front surface of the pier : too narrow bearing area and not reinforced enough

In Fig. 16 to 19, the damages done to prestressed concrete bridges are shown. In some bridges, of which precast prestressed concrete T-beams of the post-tension type had been brought in one after another for assembling in the transverse direction with a prestressing tendon, and the shoes used are made of cast iron, the mortar under the shoe was partly broken and some shoes were found cracked during the earthquake. The dimension of the beam seat of the abutment having been too small, the horizontal shearing force working on the anchor bolt of the shoe was seen to have brought about some crack on the upper part of the abutment.

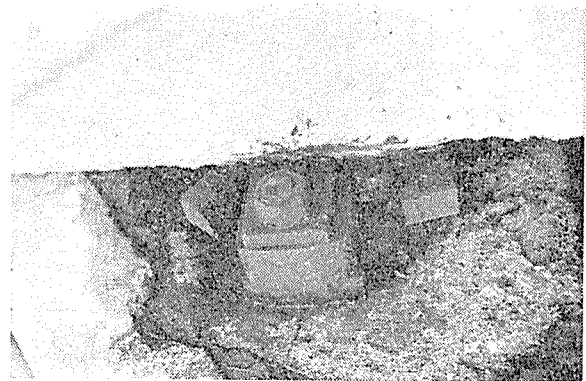
Fig. 17 (a) Break-off of bearing plate-shear key of shoes

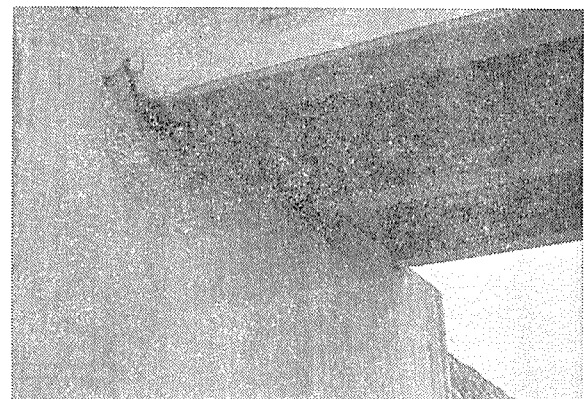
Fig. 17 (b) Tear-off of concrete (Ebino-Earthquake)

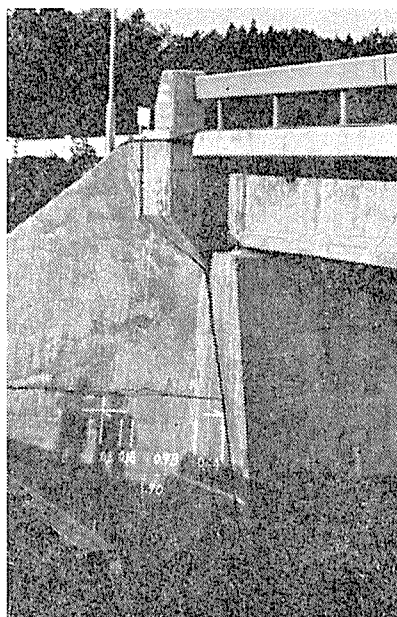
Fig. 19 Cracks at wing wall of abutment.

The cases where cracks occurred

on the wing wall near the abutment as shown in Fig. 19 were frequently seen. Cases of foundation sinking and slope face collapsing were also frequently seen.
