A REPORT ON THE BEHAVIOUR OF STRUCTURES EMPLOYING PRESTRESSED CONCRETE DURING NIIGATA EARTHQUAKE

Dr. Shunji Inomata*

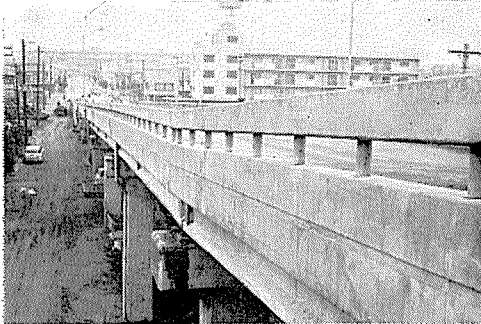
Fig. 16 Center steel span pulled off the support and collapsed over National Railway Line

is 203 m long with 8.00 m carriageway, with 15 spans. Beams were supported on reinforced concrete portal frames. There was considerable movement of the piers, some of which moved from 1 cm to 30 cm vertically relative to one another, and horizontally by as much as 40 cm at the top. Because the center steel span was not properly secured, it pulled off the supports and collapsed over the national railway line (Fig. 16). Apart from minor spalling over the piers at deck level, the prestressed portion of the structure was undamaged (Fig. 17, 18, 19)
