Damage Inflicted on Concrete Structures during Tokachioki Earthquake and Concept on Aseismic Design

By **Tatsuo Nishiki***
Yoshio Ozaka**

1. Preface

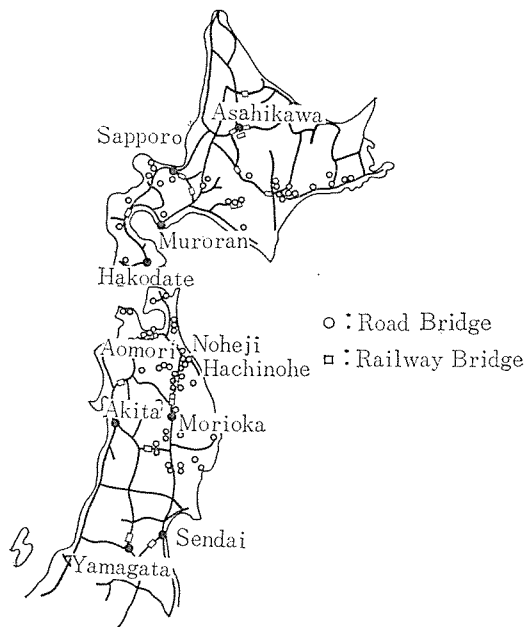
Fig. 15 Sites of the investigated prestressed concrete bridges

Almost all the prestressed concrete structures in the Hokkaido and Tohoku regions are bridges of the simple beam or continuous beam type. Distribution of these bridges is as given in Fig. 15. There is quite a number of these bridges in the areas, and some damage was anticipated before the investigation begun.

However, on investigation almost no damage was found inflicted on the superstructures of prestressed concrete bridges themselves. Only in a very small number of them, the main beam was found to have moved about 1 to 3 cm at the right
